Mayaro and Guayaguayare Coastal Protection

Stakeholder Consultation

17th November 2015

“Appraisal and design of sustainable coastal protection measures to address ongoing coastal erosion and coastal flooding problems at Mayaro and Guayaguayare”

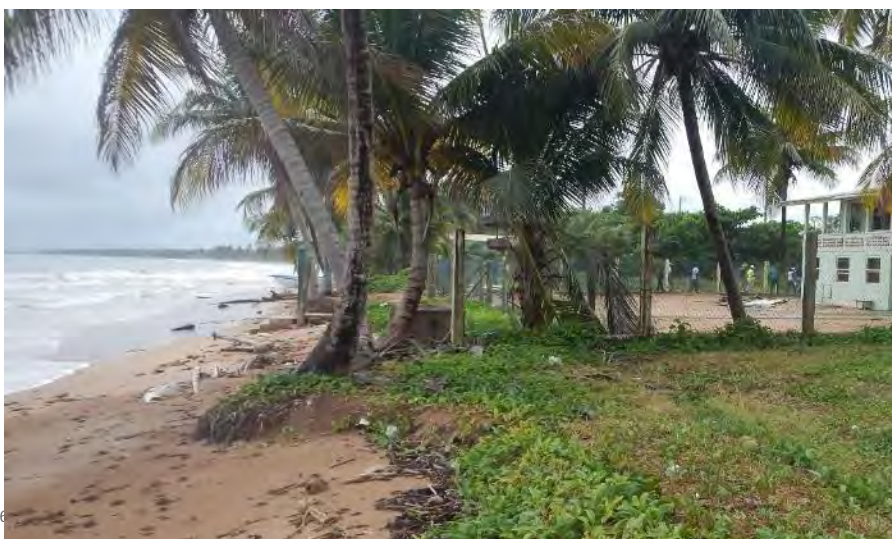
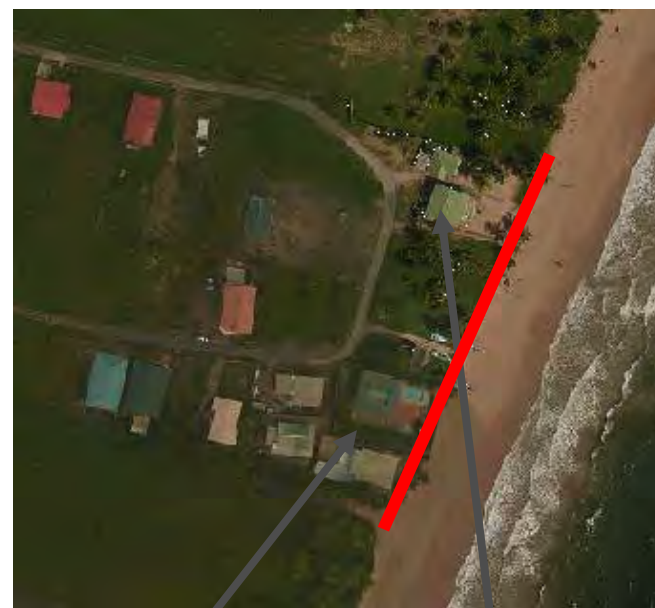
M2_P2 – Property cluster

- Eroding shoreline
- Scheme currently viable at property cluster only
- *Recommendation*: Rock revetment/berm at top of beach (BCR>2)

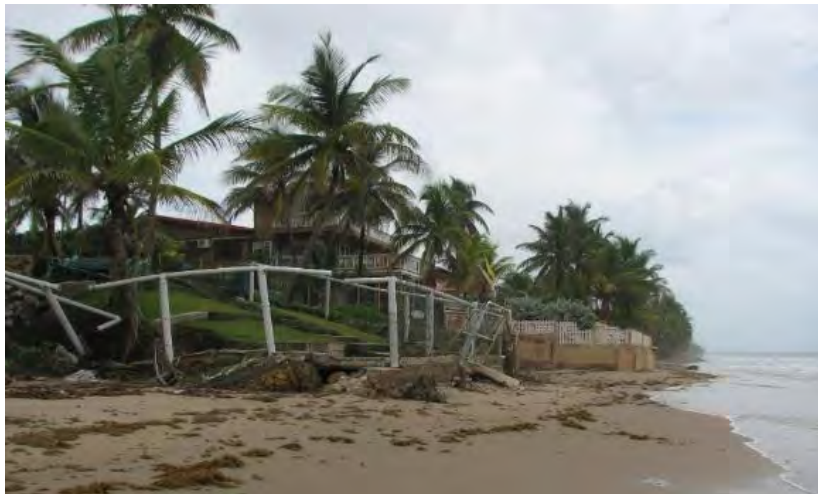
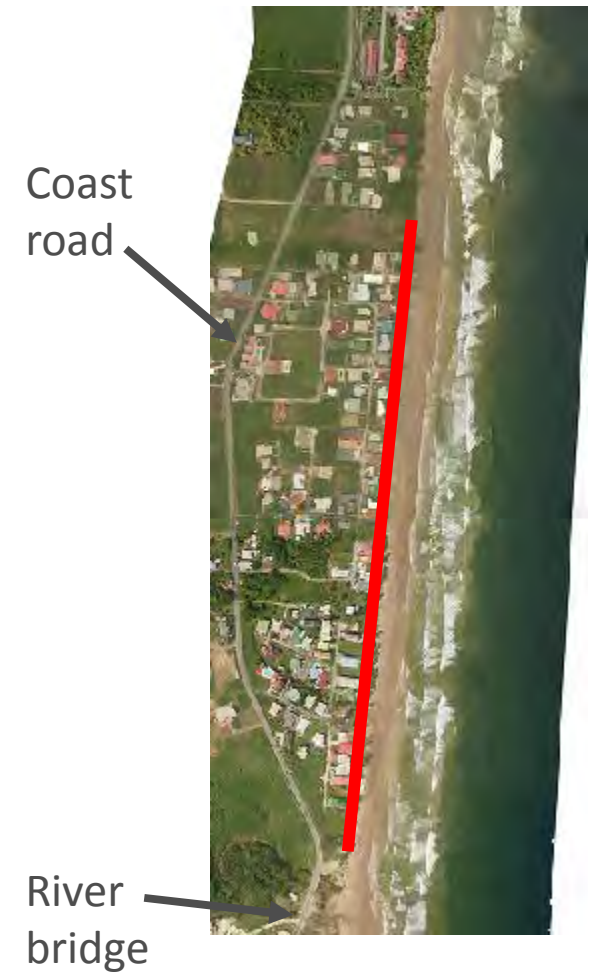
M6_P1 – Indian Beach/Frontin Road

- Large number of high value assets at direct risk
- Narrow beach and property wall collapses, unstable ground
- *Recommendation*: Revetment or possibly beach nourishment and groynes (BCR>2)

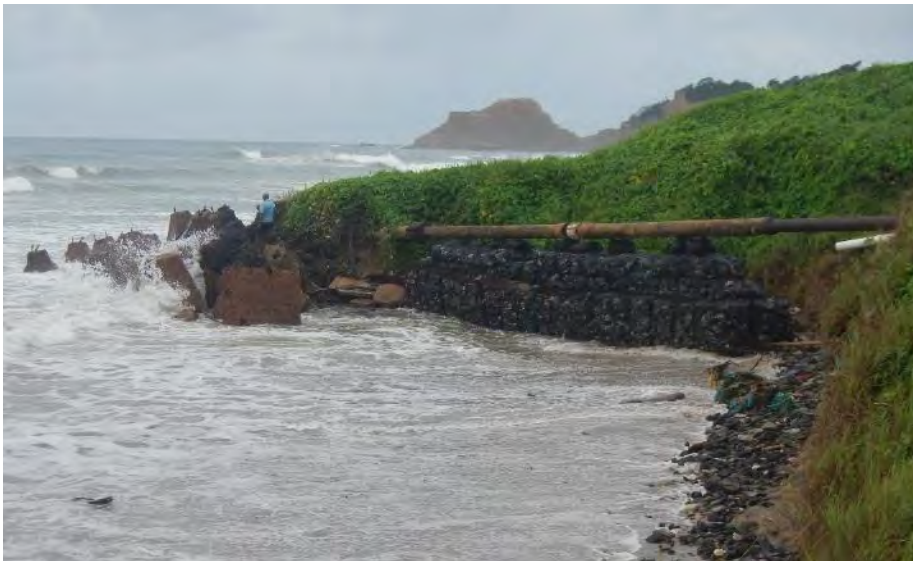
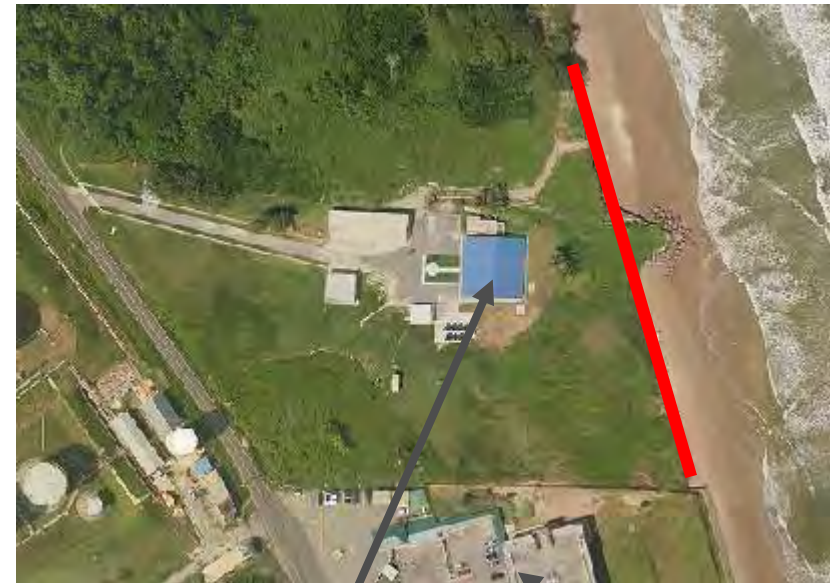
M9_P1 – Coastguard facility

- Pipeline and coastguard critical facility at risk
- Clearly eroding frontage
- *Recommendation*: Rock revetment (BCR>3)

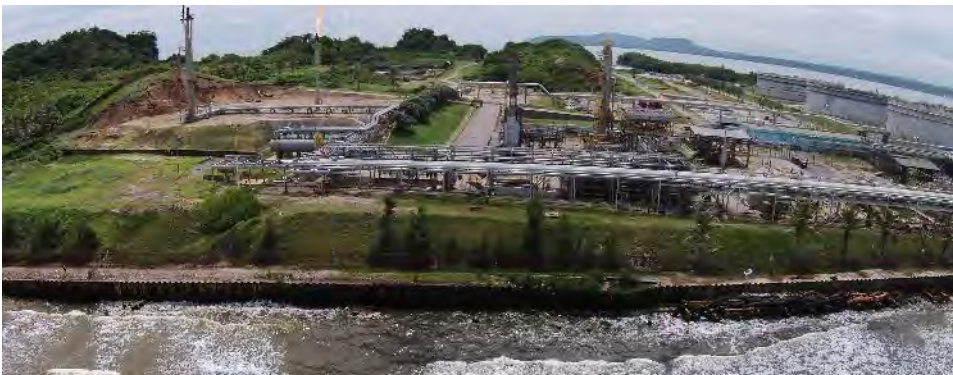
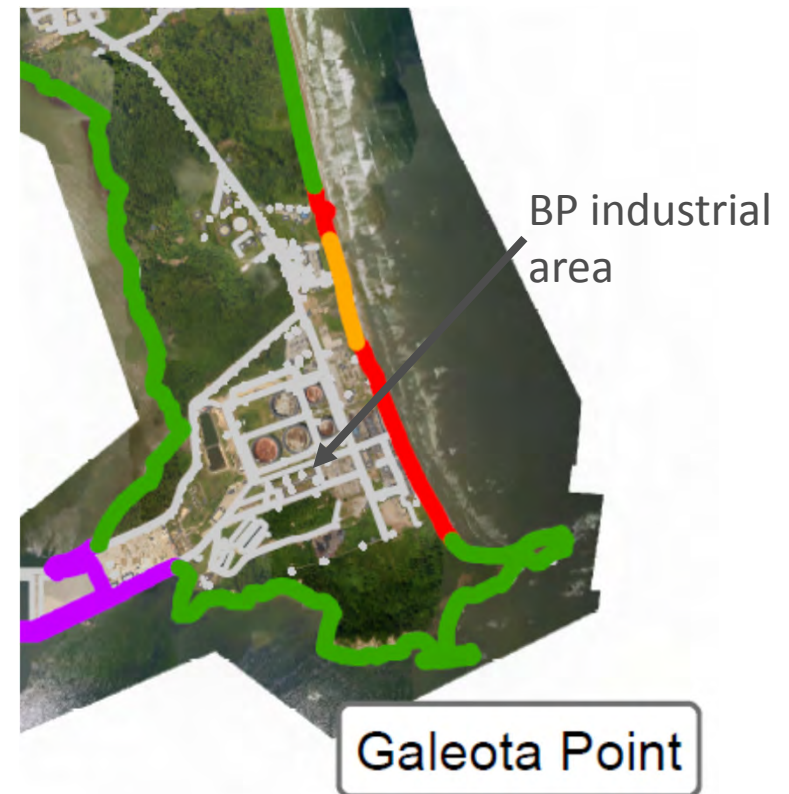
M10_P3 – BP Frontage

- High value private industrial frontage with existing failed wall
- High exposure, avoid reflective solution
- Little chance of holding beach
- Poor construction access
- *Recommendation:* Leave wall in place (replace sections where needed) and rock revetment in-front (BCR>4)

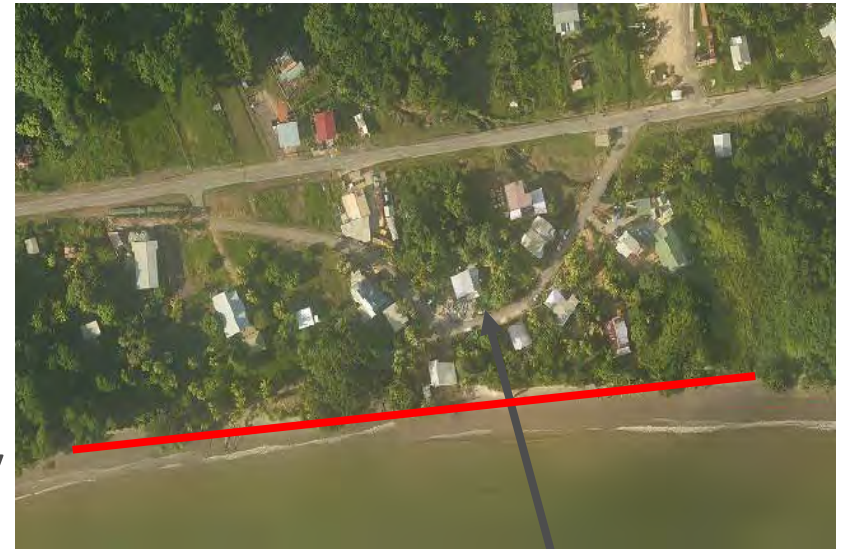
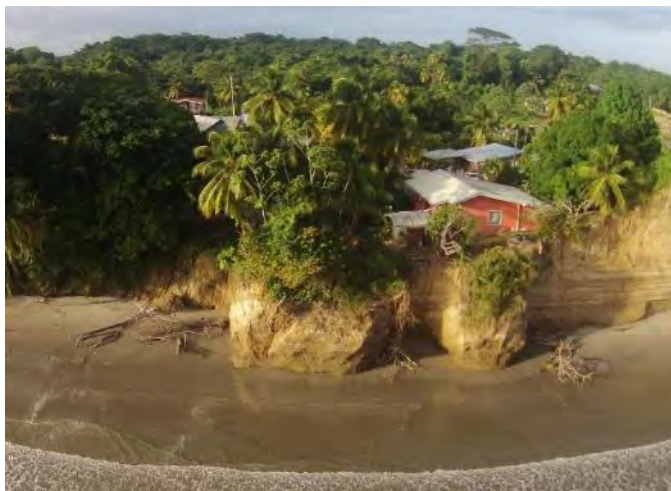
G3_P1 – Calmapass

- Naturally eroding soft cliff
- Difficult economic justification for scheme but community affected
- *Recommendation*: Need to consider cost effective solutions to justify any scheme. If viable, likely to comprise low rock berm to manage retreat (BCR<1)

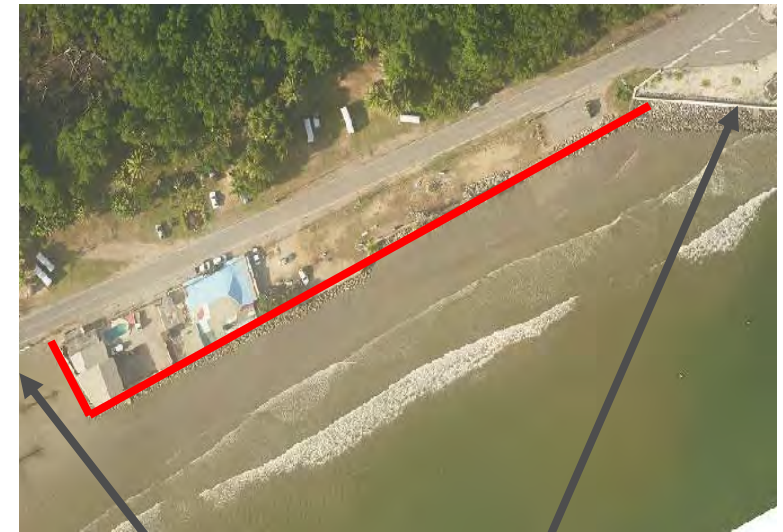
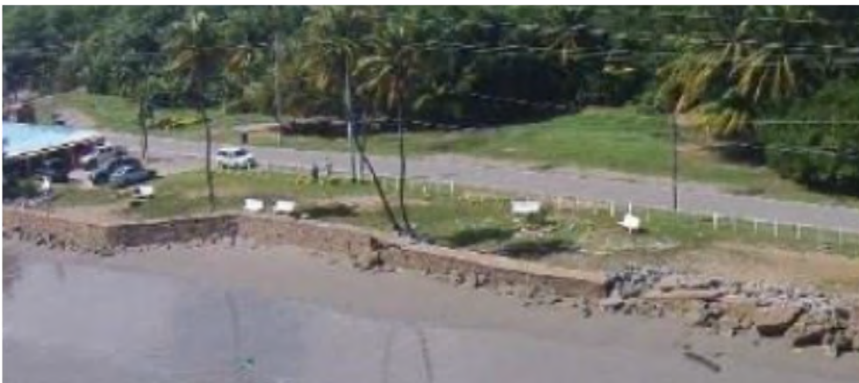
G5_P1 – Seawall west of new fishing facility

- Seawall has failed and rock protection added as emergency measure
- Coast road and property at risk
- Option for improved amenity space
- **Recommendation:** Rock revetment with seawall to the east and rock toe protection to the west (BCR>10)

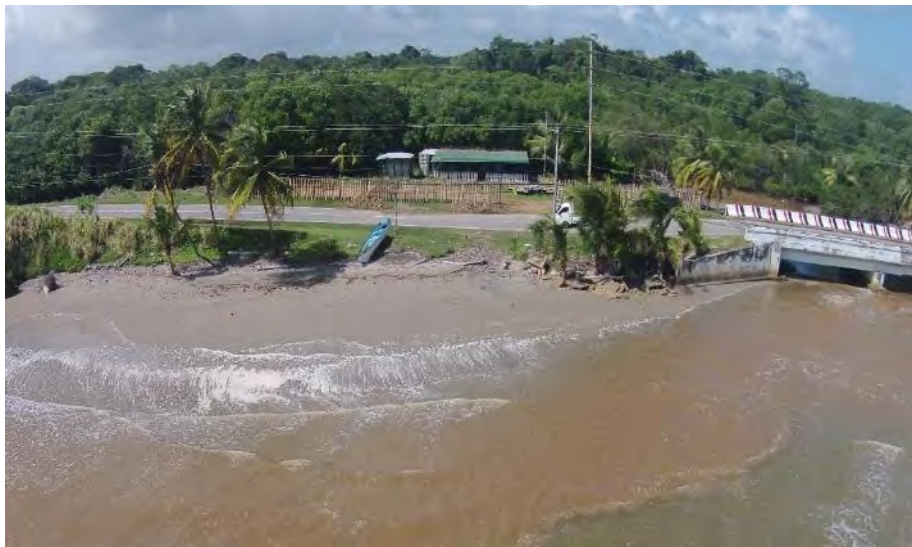
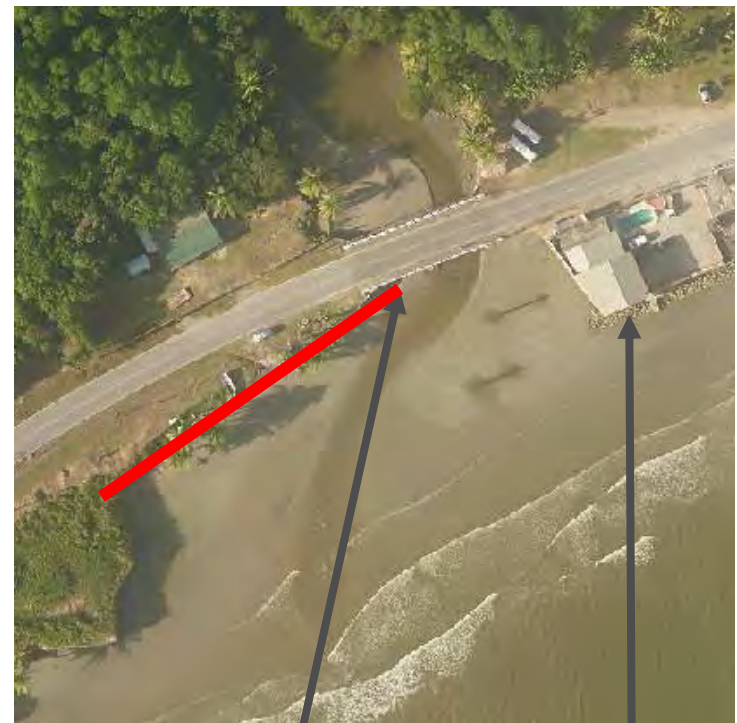
G5_P2 – Guayaguayare road

- Road is high value asset
- Eroding shoreline, close to road, threat to bridge.
- *Recommendation*: Revetment with seawall (BCR>15)

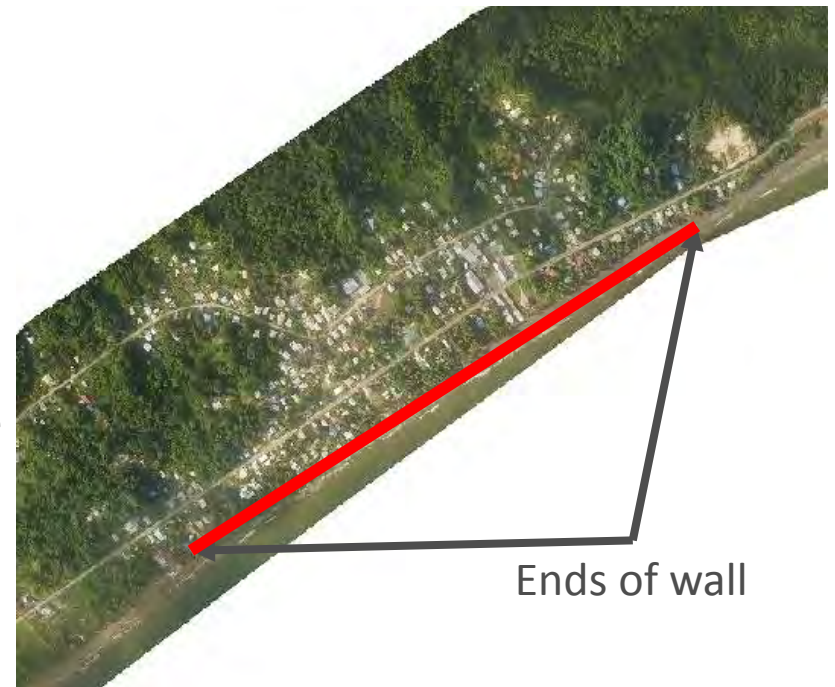
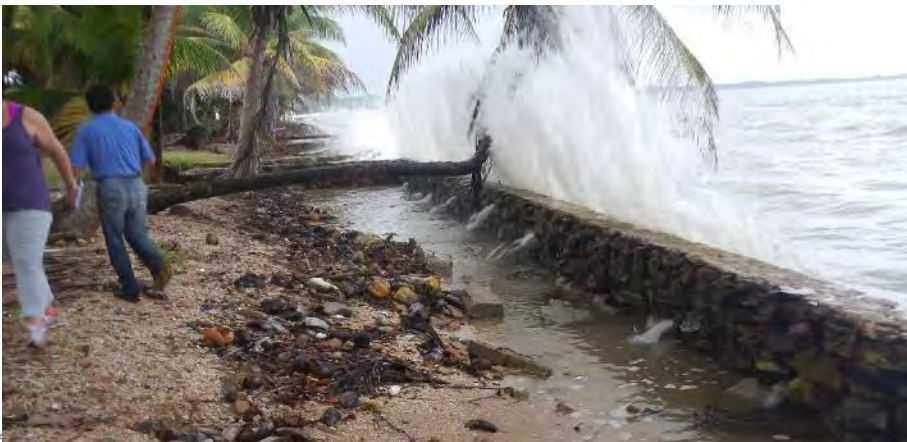
G6_P2 – Guayaguayare seawall

- Wave overtopping and beach loss at this vertical wall
- Wall is not performing, but modifications could protect assets
- *Recommendation*: Modify wall by including set back wave wall and toe protection as required (BCR>2)

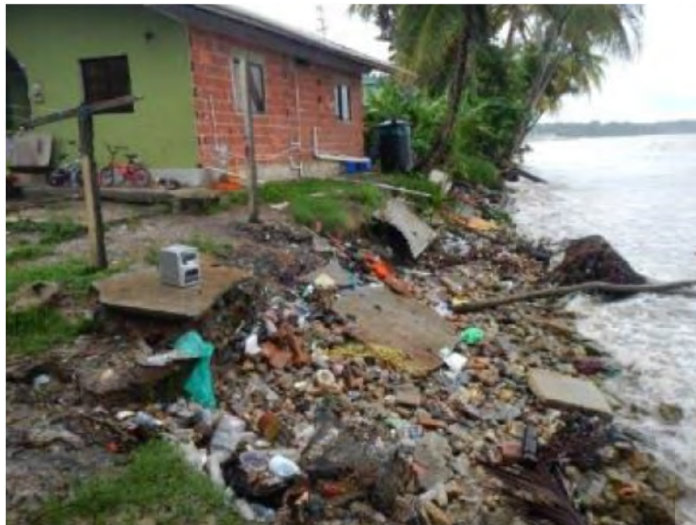
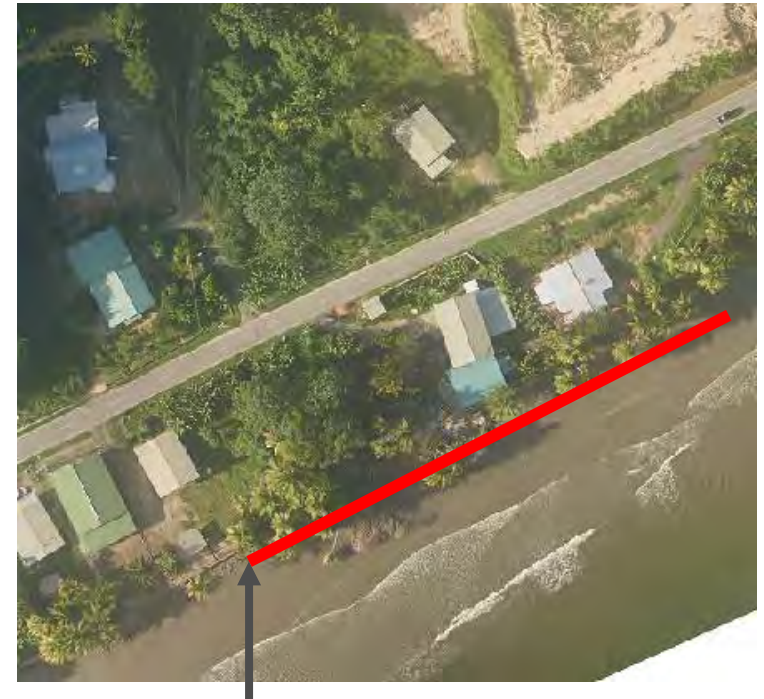
G6_P1 – East Guayaguayare

- Seawall stops short of property and road at risk
- *Recommendation:* Extend existing seawall with toe protection and wave wall (BCR>2)

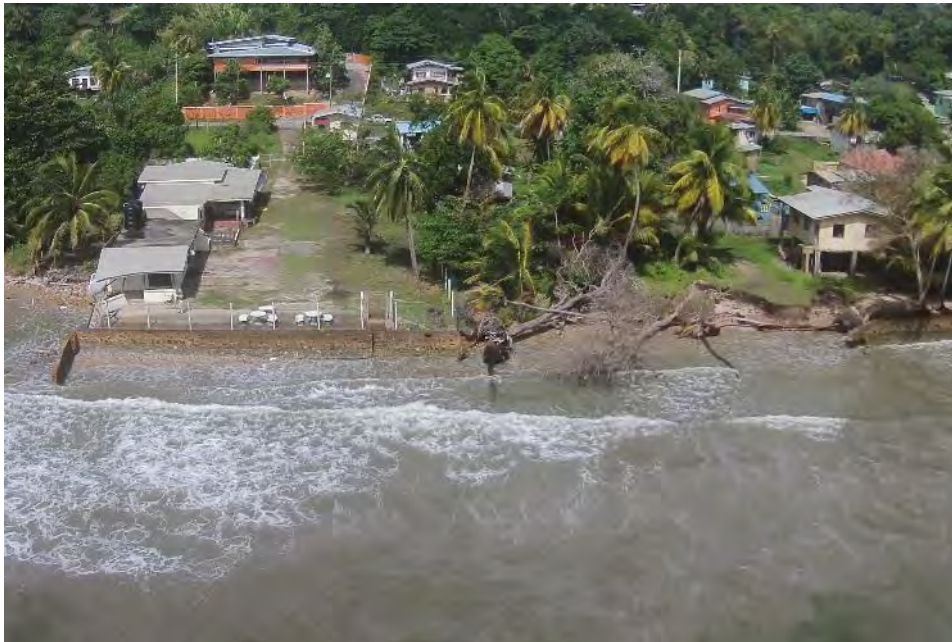
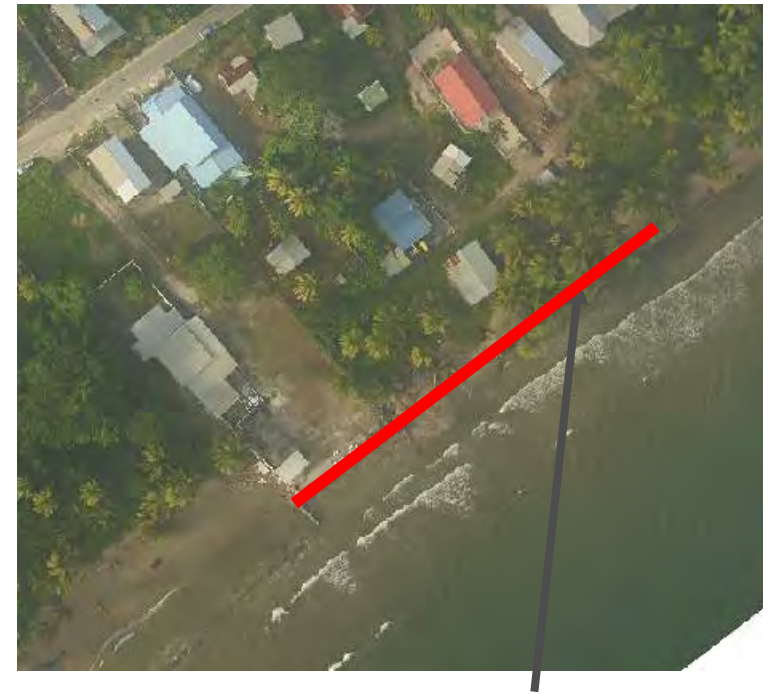
G6_P3 – West Guayaguayare

- Seawall stops short of property at risk
- *Recommendation*: Extend existing seawall with wave wall and toe protection (BCR>2)

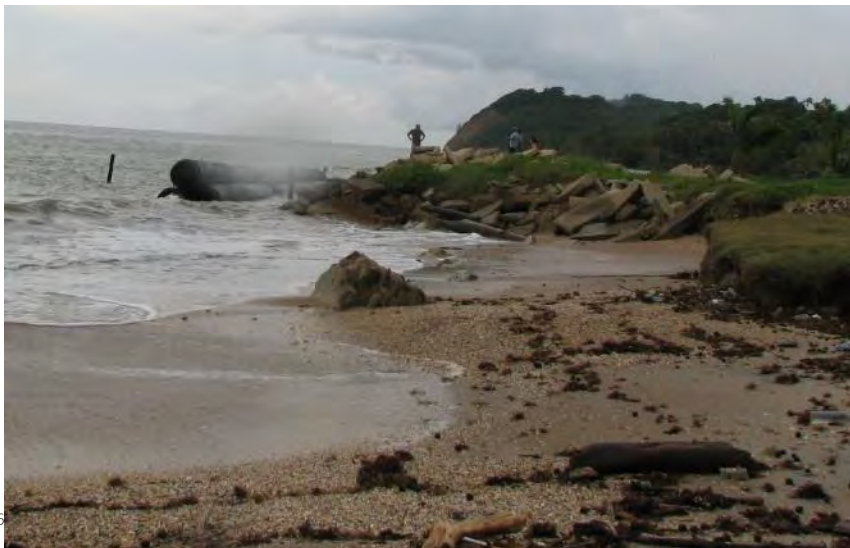
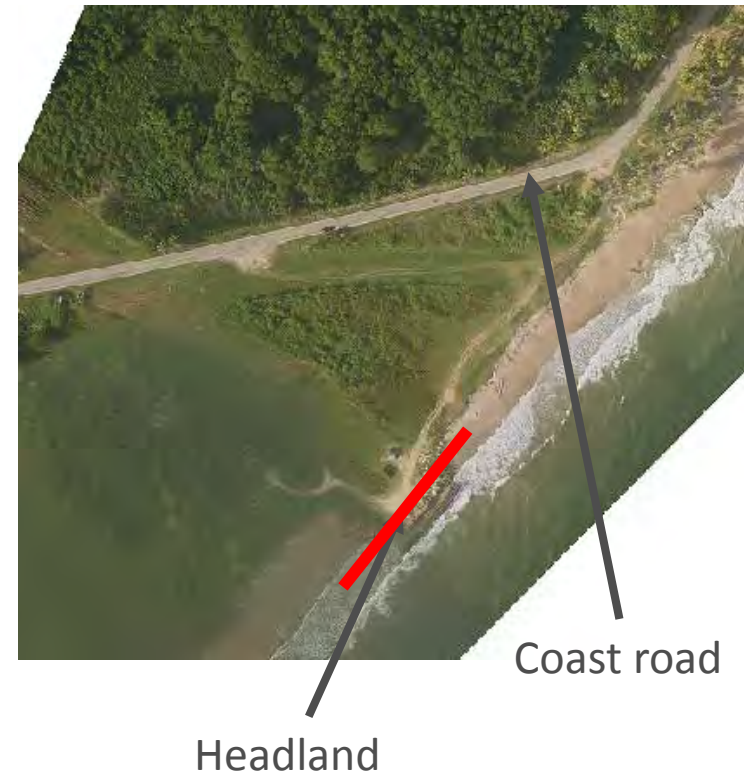
G8_P2 – Oil pipelines

- Headland is also protecting road
- High value asset and economically/environmentally justified to intervene when required
- **Recommendation:** Identification of risk only. Rock revetment may be appropriate. (BCR>20)
